## Stereo Hi-Fi Balun 500028

### Quick Installation Guide

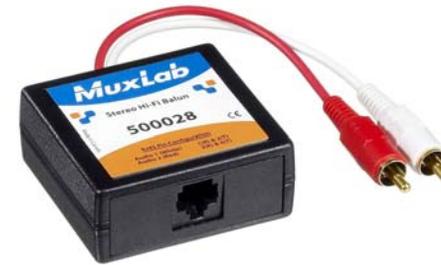
The Stereo Hi-Fi Balun (500028) allows unbalanced line level stereo audio to be transmitted up to 5,000 ft (1.5 km) via an unshielded copper twisted pair (UTP) cable in a point-to-point connection. Used in pairs, the product is designed for high fidelity applications where full audio bandwidth (20 Hz to 20 kHz) is required. Used in pairs, the Stereo Hi-Fi Balun eliminates costly and bulky audio cables, allowing audio equipment to be connected or moved within a structured cabling environment. Applications include: Audio distribution, high-fidelity sound systems, and custom residential audio systems.

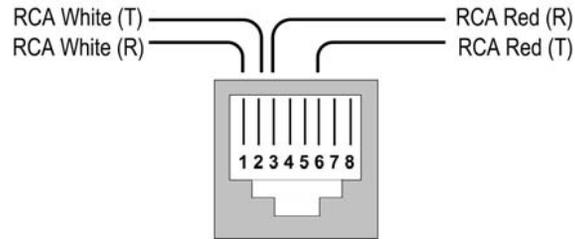
1. One pair of Stereo Hi-Fi Baluns is required for each stereo channel.
2. Identify the pin configuration of the baluns. Two (2) twisted pairs are required as shown in the following diagram.

**Note:** The Stereo Hi-Fi Balun is phase polarity sensitive. Therefore, in order to achieve full stereo audio quality, please ensure that the wiring is straight-through and according to EIA568 (A or B) standard.
